Rainbow:

Colour in component caused by diffraction

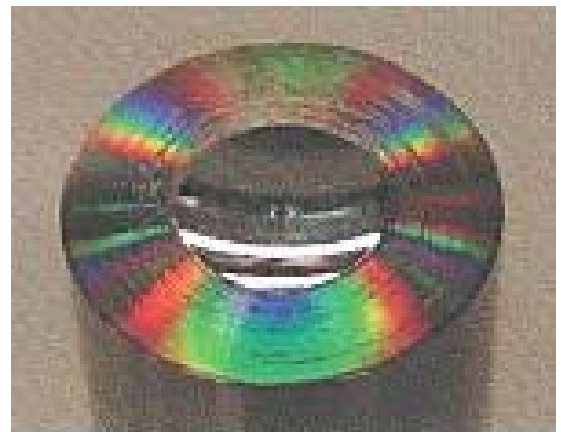
Rainbow is 'light scatter' and is sometimes seen in the component being cut.

One cause for this phenomenon is chips in the tool cutting edge. Contour takes great care when lapping the cutting edge and we inspect it at x500 under a Nomarski microscope. We are confident that tools are chip free when we supply them.

The material being cut can also cause rainbow: Cutting with a perfectly sharp diamond tool, on a very stiff machine, in a perfect material with small crystals, always gives a fine 'grid' in the surface finish. If the grid has the right dimensions diffraction (rainbow) is seen on the surface. The stitch of the grid must be very small to avoid the colours on the surface. (Feed/Rev or stitch $\sim 1\mu\text{m}$, depends on the tool radius size). Altering 'speeds and feeds' can change this.

- Avoid chipping of the tool cutting edge. There should be a minimum handling of tools prior to fitting to the machine. There should be no reason to clean or inspect tools as Contour takes responsibility for this. Tools should always be kept in their containers (other than when fitted to the machine).
- Follow Contour's tool handling procedures when setting the tool into the lathe.
- When rainbow is seen, first of all, check that coolant/chip removal is optimised.
- If there is some impurity in the metal like Fe or Cr, then this can cause such a problem. NiP must have the right content of phosphorus, around 12% - 14% is recommended.
- If there is some imbalance or bad clamping of the tool, toolholder or insert (mould) this will cause vibration that can damage the cutting edge of the diamond tool (chipping) and result in rainbow.
